Articulated Flex Lance Safety Stop

June 22, 2010

Service Bulletin No.: 36-015-003/1

Part No.: 36-015-003

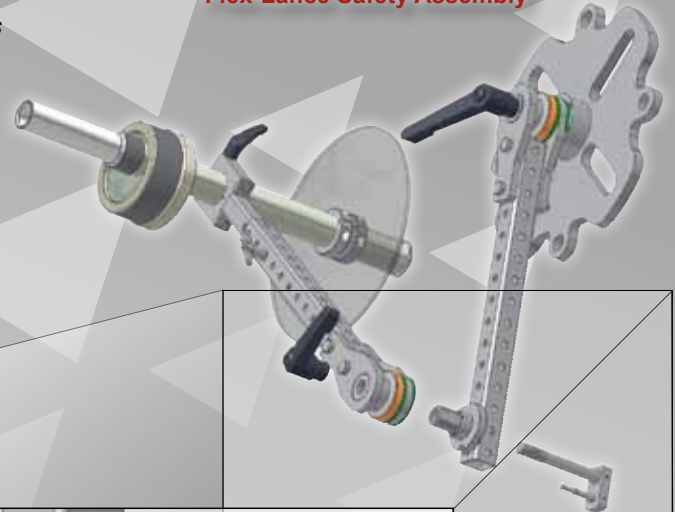
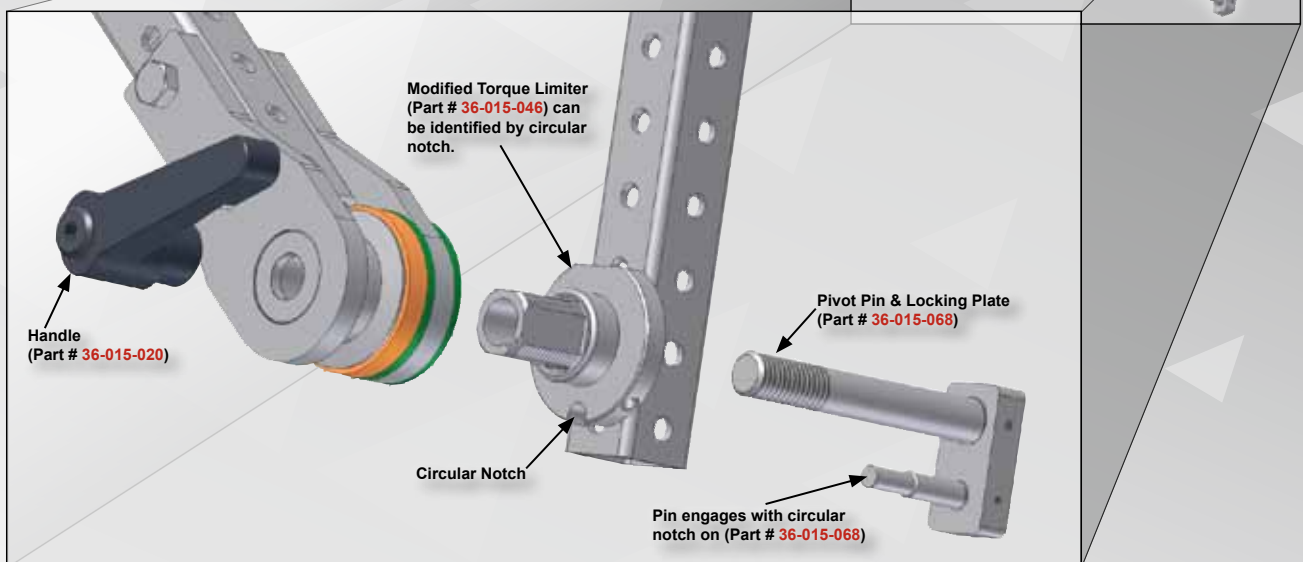
“Chicken Wing”
Flex-Lance Safety Assembly

This service bulletin applies to the lower elbow of the “Chicken Wing” flex-lance safety assembly. (Please refer to the attached explanatory diagram.) It has come to our attention that the Pivot Pin Locking Plate Assembly/Weldment (Part # 36-015-052), in certain instances, may have a weak weld joining the Pivot Pin to the Locking Plate. The same concern also applies to a small bar welded to Telespar One (Part # 36-015-018), which locks the Modified Torque Limiter (Part # 36-015-036) and prevents it from rotating during adjustment.

These concerns are fully addressed by replacing the Pivot Pin Locking Plate and the Torque Limiter with new parts, which have been modified. Please see the diagram below.

1. Remove Handle (Part # 36-015-028). This will enable the complete lower elbow joint to be separated into its components.
2. Remove the Torque Limiter (Part # 36-015-046) *Note: The new part has a circular notch at its lower edge. The old part does not have this notch.*
3. Remove the old Pivot Pin Locking Plate (Part # 36-015-052). *Note: The new part has a much thicker plate.*
4. Insert the new Pivot Pin Locking Plate Assembly (Part # 36-015-068). The shorter pin must engage the hole below the Pivot Pin and protrude through the opposite side of the Telespar arm.
5. Install the modified Torque Limiter (Part # 36-015-046) Engage the circular notch with the pin from the Pivot Pin Locking Plate.
6. Reassemble the other components.
